# **DETTONATION-FRAME ARRESTER DEVICES**

## **FOR GASOLINE CARGO VAPOR RECOVERY SYSTEM**

R. A. BJORKLUND AND P. R. RYASON

## FINAL REPORT

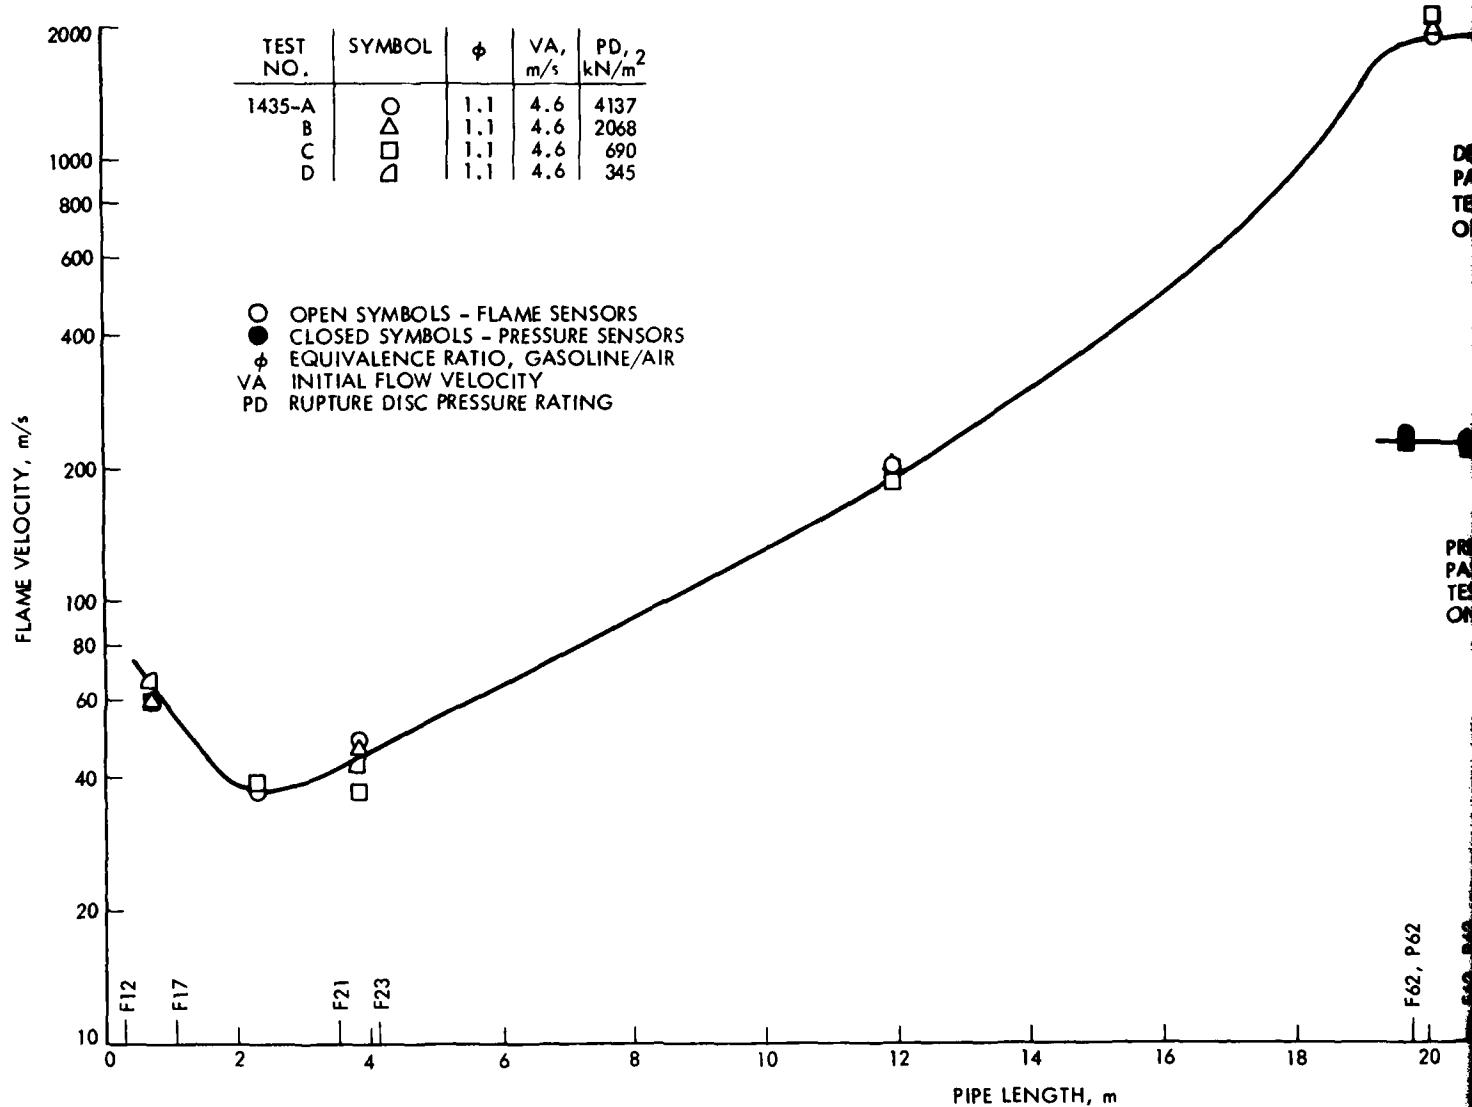
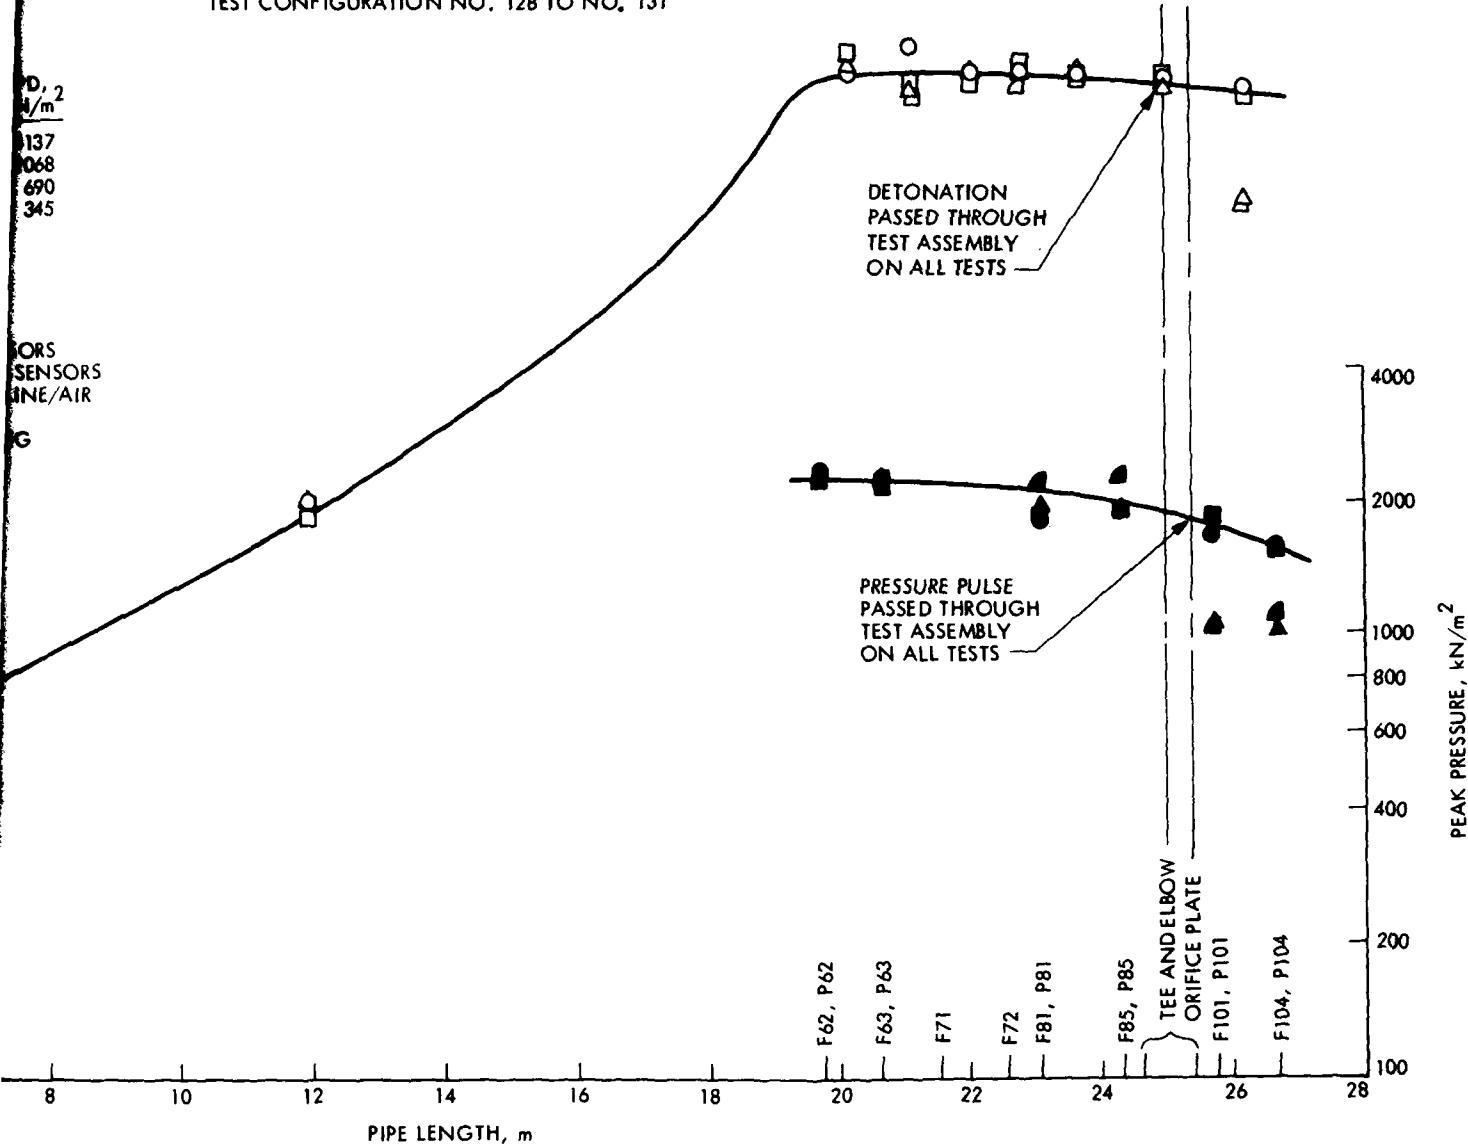
Figure 8-4. Pipe Tee Rupture Disc Not-In-line, and Pipe Elbow Assembly Test Results

Four test firings were made with this test configuration (No. 128 to No. 131) where the pressure rating of the rupture disc was reduced in the same steps as above. The rupture disc was blown out in all test firings and the detonation passed through the test assembly. Figure 8-4 is a plot of the results for these tests. For two tests, the flame velocity and peak pressure in the witness section showed only a slight drop in levels. For the two other tests, the drop was more significant. However, there is still no apparent correlation between this loss and the rupture-disc pressure rating. It appears to be a random phenomenon. The measured pressure drop across the test

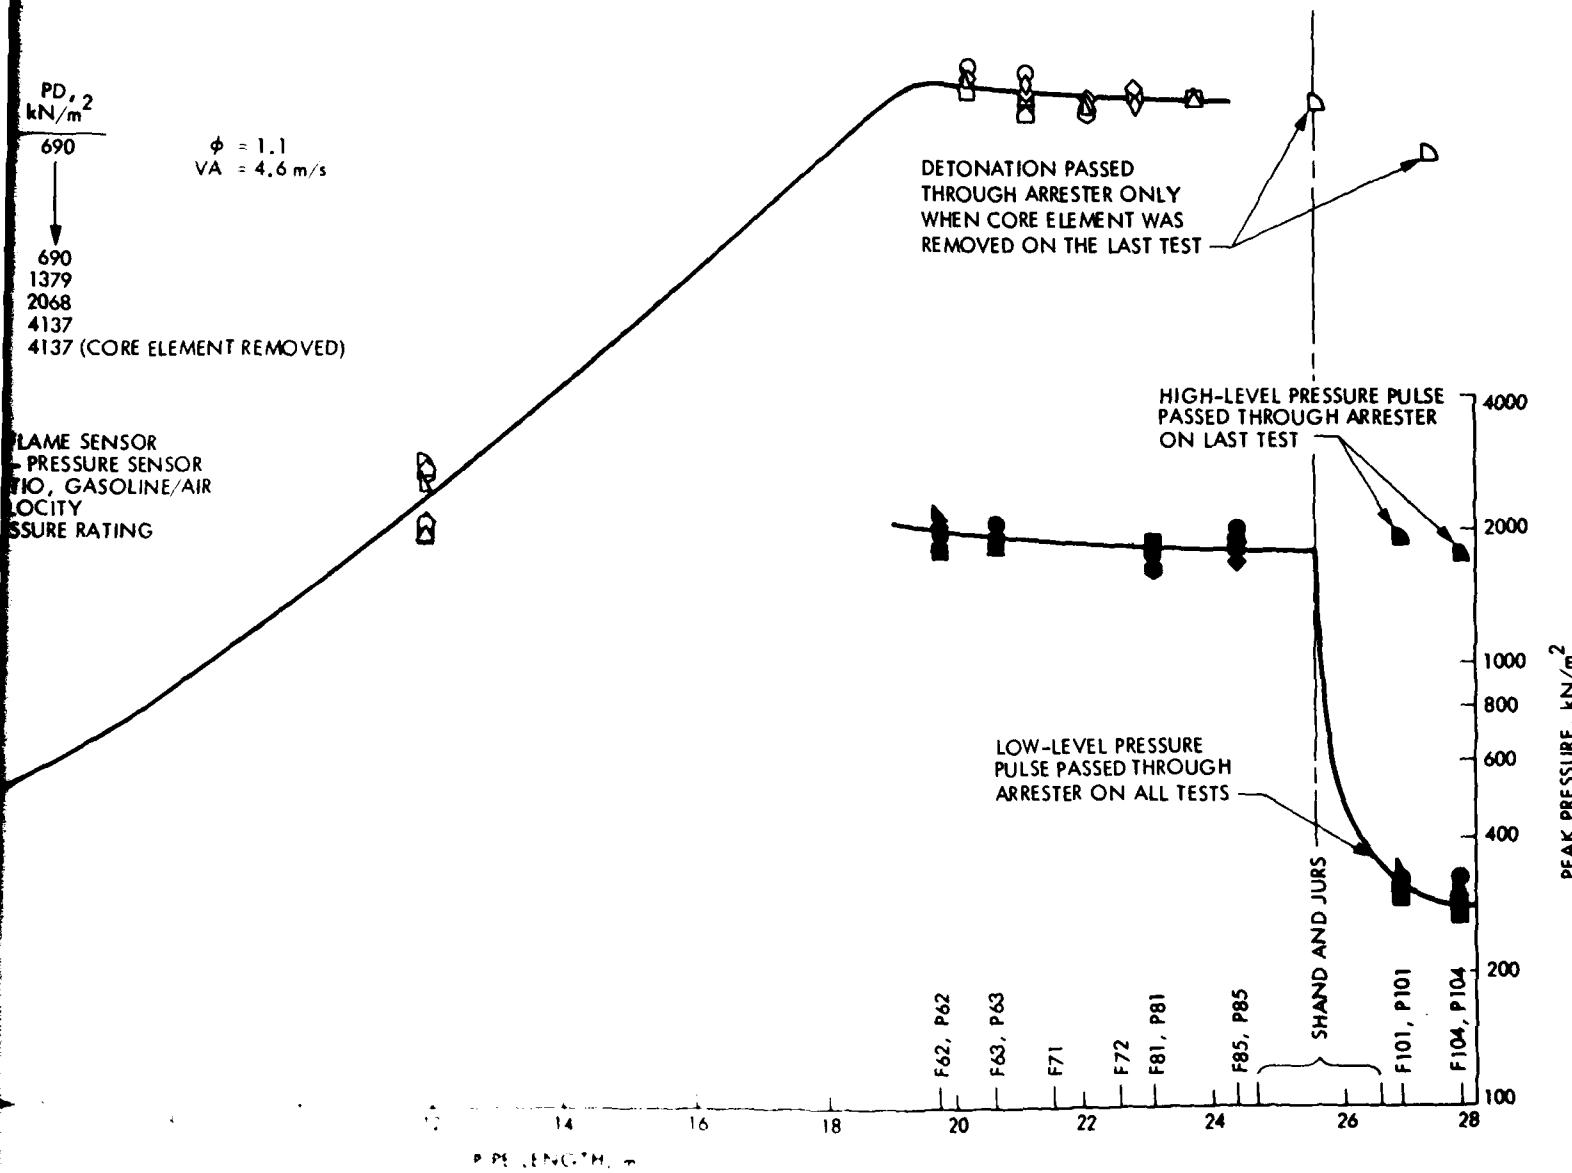
FIGURE 8-7. Shand and Jurs Spiral-Wound, Crimped Aluminum Ribbon Arrestor Assembly Test Results

- (3) The Shand and Jurs spiral-wound, crimped aluminum ribbon arrester test assembly sustained nine detonations without serious damage. The detonation did not pass through the arrester. Pre- and posttest pressure loss averaged  $0.152 \text{ kN/m}^2$  (0.022 psid).

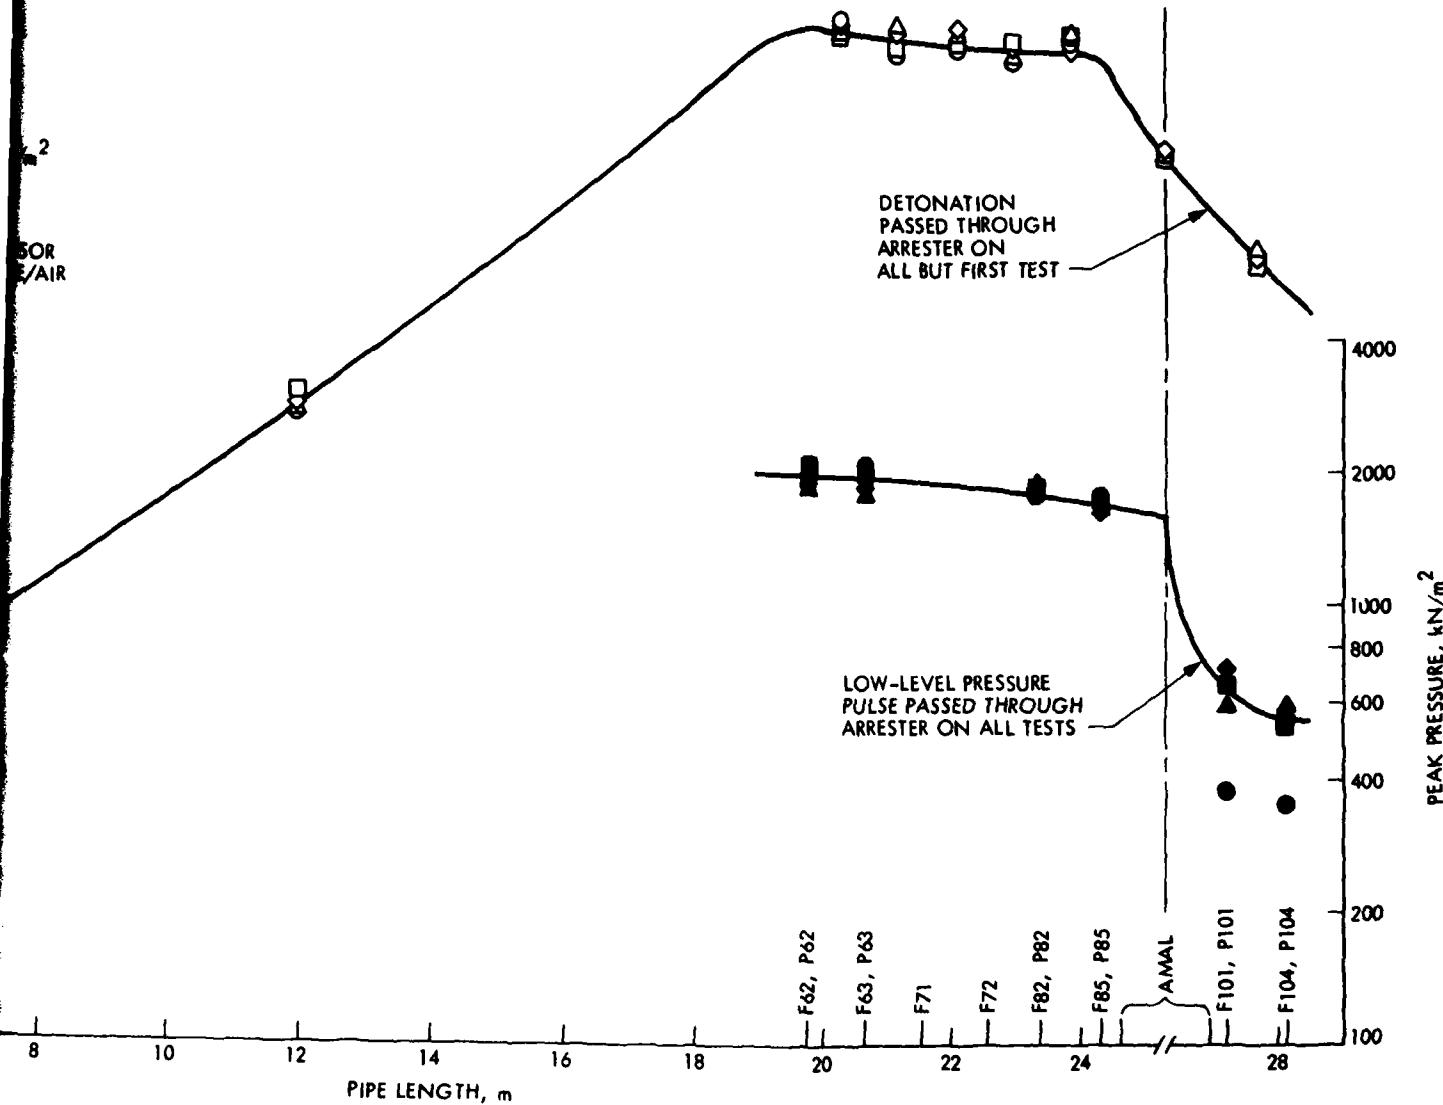
Figure 8-11. Amal Spiral-Wound, Grimped Stainless-Steel Ribbon Arrestor Assembly Test Results

- (4) The Amal spiral-wound, crimped stainless-steel ribbon arrester test assembly sustained four detonations without any visible damage. The detonation was arrested in the first firing, but passed through in the other three. Pre- and posttest pressure loss averaged  $0.428 \text{ kN/m}^2$  (0.062 psid).

The pre- and posttest pressure drop across the Amal arrester test assembly did not vary appreciably. It averaged  $0.428 \text{ kN/m}^2$  (0.062 psid) for an average air flow velocity of 4.78 m/s (15.68 ft/s). Posttest inspection of the core element showed no evidence of damage that could have caused the failure. The retainer grid was bowed downstream 0.64 cm (0.25 in.) at the axial centerline, indicating that some distortion had occurred to the core element under the detonation wave loading, but apparently the core element had returned to its original shape.

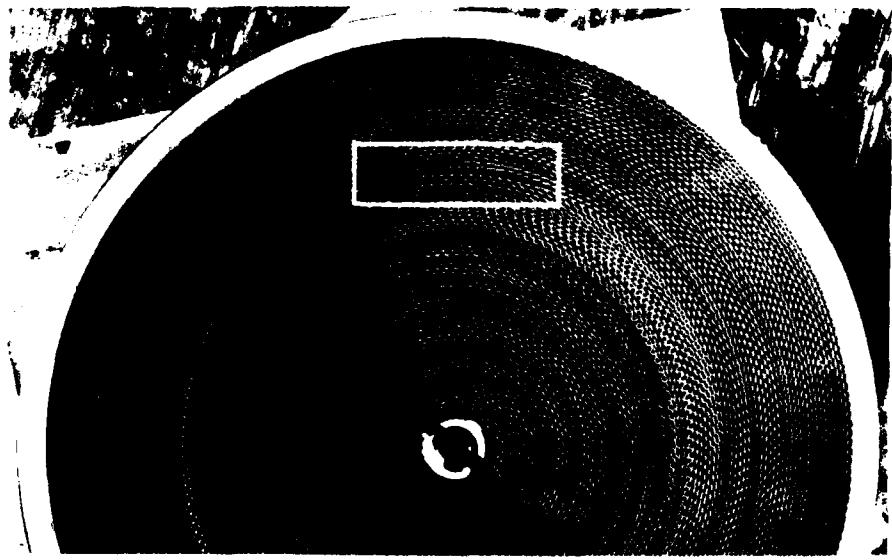
Figure 13-3. Spiral-Wound, Crimped Stainless-Steel Ribbon Core Element, 30.5-cm Diameter by 15.2-cm Length, Posttest

- (1) The 15.2-cm- (6-in.-) long stainless-steel Shand and Jurs arrester configuration, with the indirect inlet piping and a  $690 \text{ kN/m}^2$  (100-psid) rupture disc, arrested four detonations. On the fifth test, the detonation passed through the arrester. Posttest inspection revealed a small separation in the crimped ribbon winding. Pre- and posttest pressure loss averaged  $0.151 \text{ kN/m}^2$  (0.022 psid). Downstream pressure pulse measurements averaged  $344 \text{ kN/m}^2$  (49.9 psia).

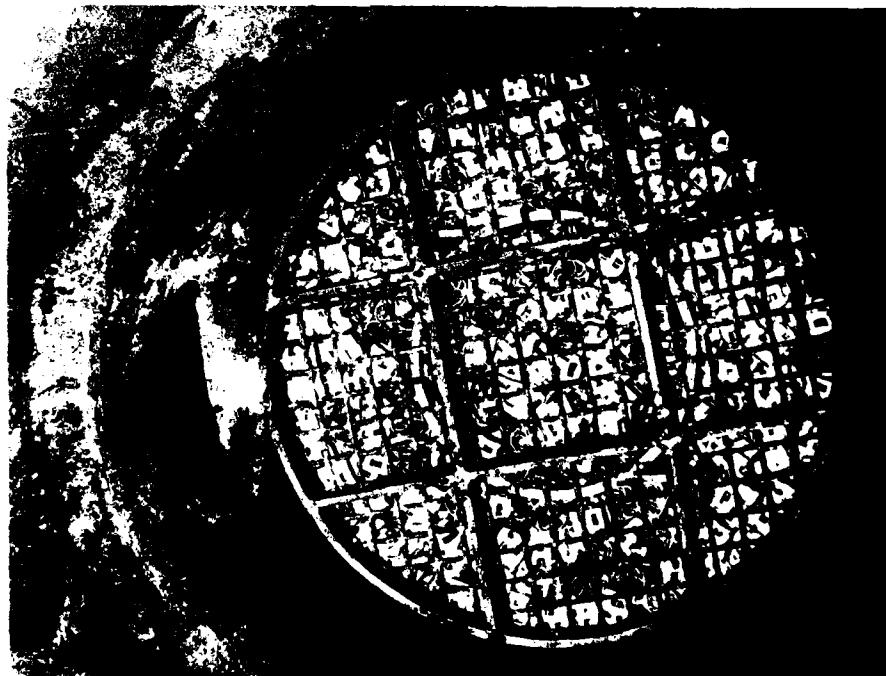
Figure 13-19. Posttest Compacted Bed of Aluminum Ballast Rings

- (7) The vertical bed of the Ballast rings arrester test assembly sustained five detonations with only minor distortion of the rings caused by bed compacting. The detonation did not pass through the arrester. Pre- and posttest pressure loss averaged  $0.048 \text{ kN/m}^2$  (0.007 psid).
